**On the trail of Halifax bomber BB378 of 138 Squadron from RAF Tempsford  
Crash-landed in Denmark on 11.12.1943**

## **Metal detector survey**

**David Barry, Kalundborg Archaeology Society, 24.02.2015**  
**David@Barry.DK**

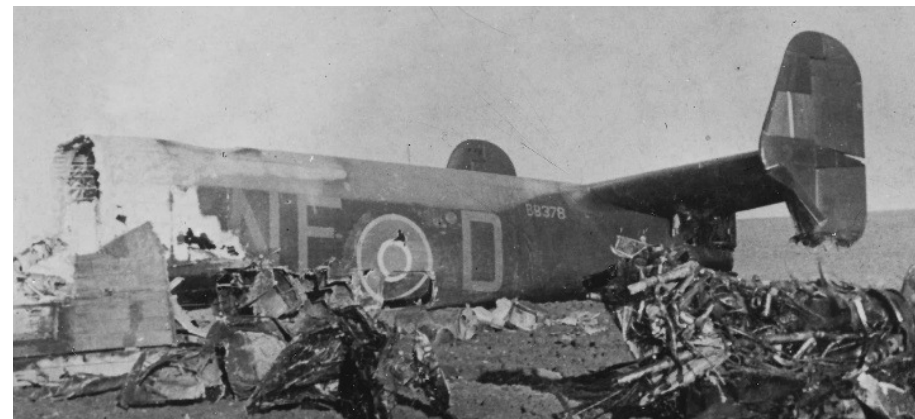
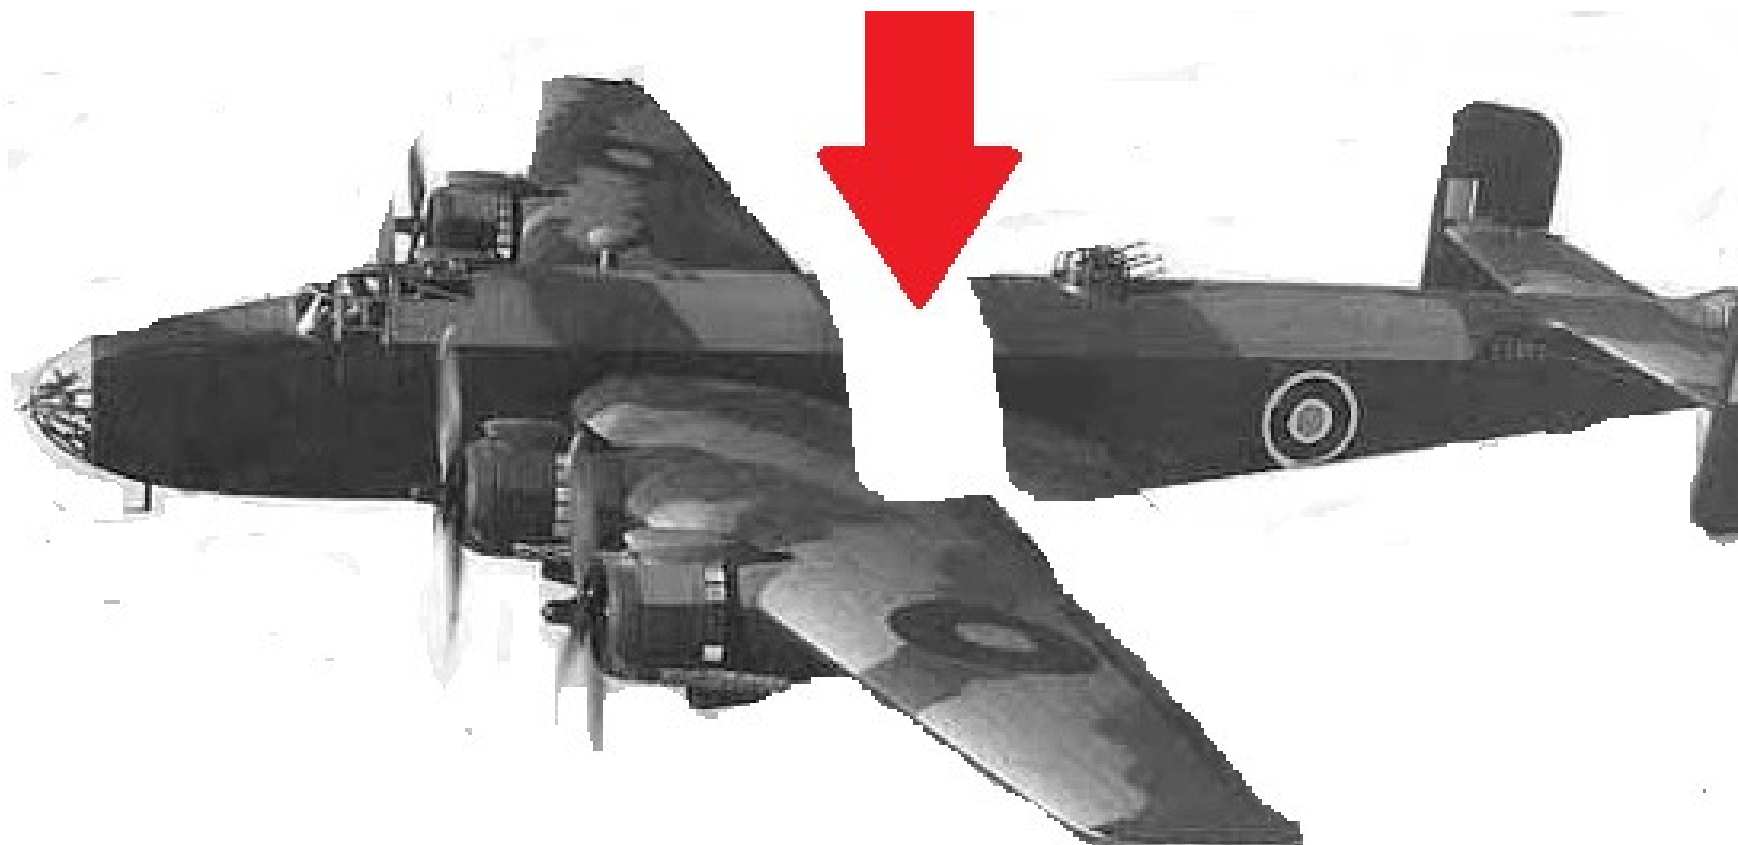
As is apparent from the photograph, only the rear end of the fuselage aft of the entrance door remained somewhat intact after the crash-landing and ensuing fire and explosions, even though the aircraft was intact at the time of landing as evidenced by the above report. The front half of the aircraft (forward of the red arrow) was completely destroyed. There should therefore be many small items of wreckage and ammunition remaining in the soil at the crash site. The SOE Halifaxes were modified and did not have upper-mid and nose turrets, unlike on the image below.

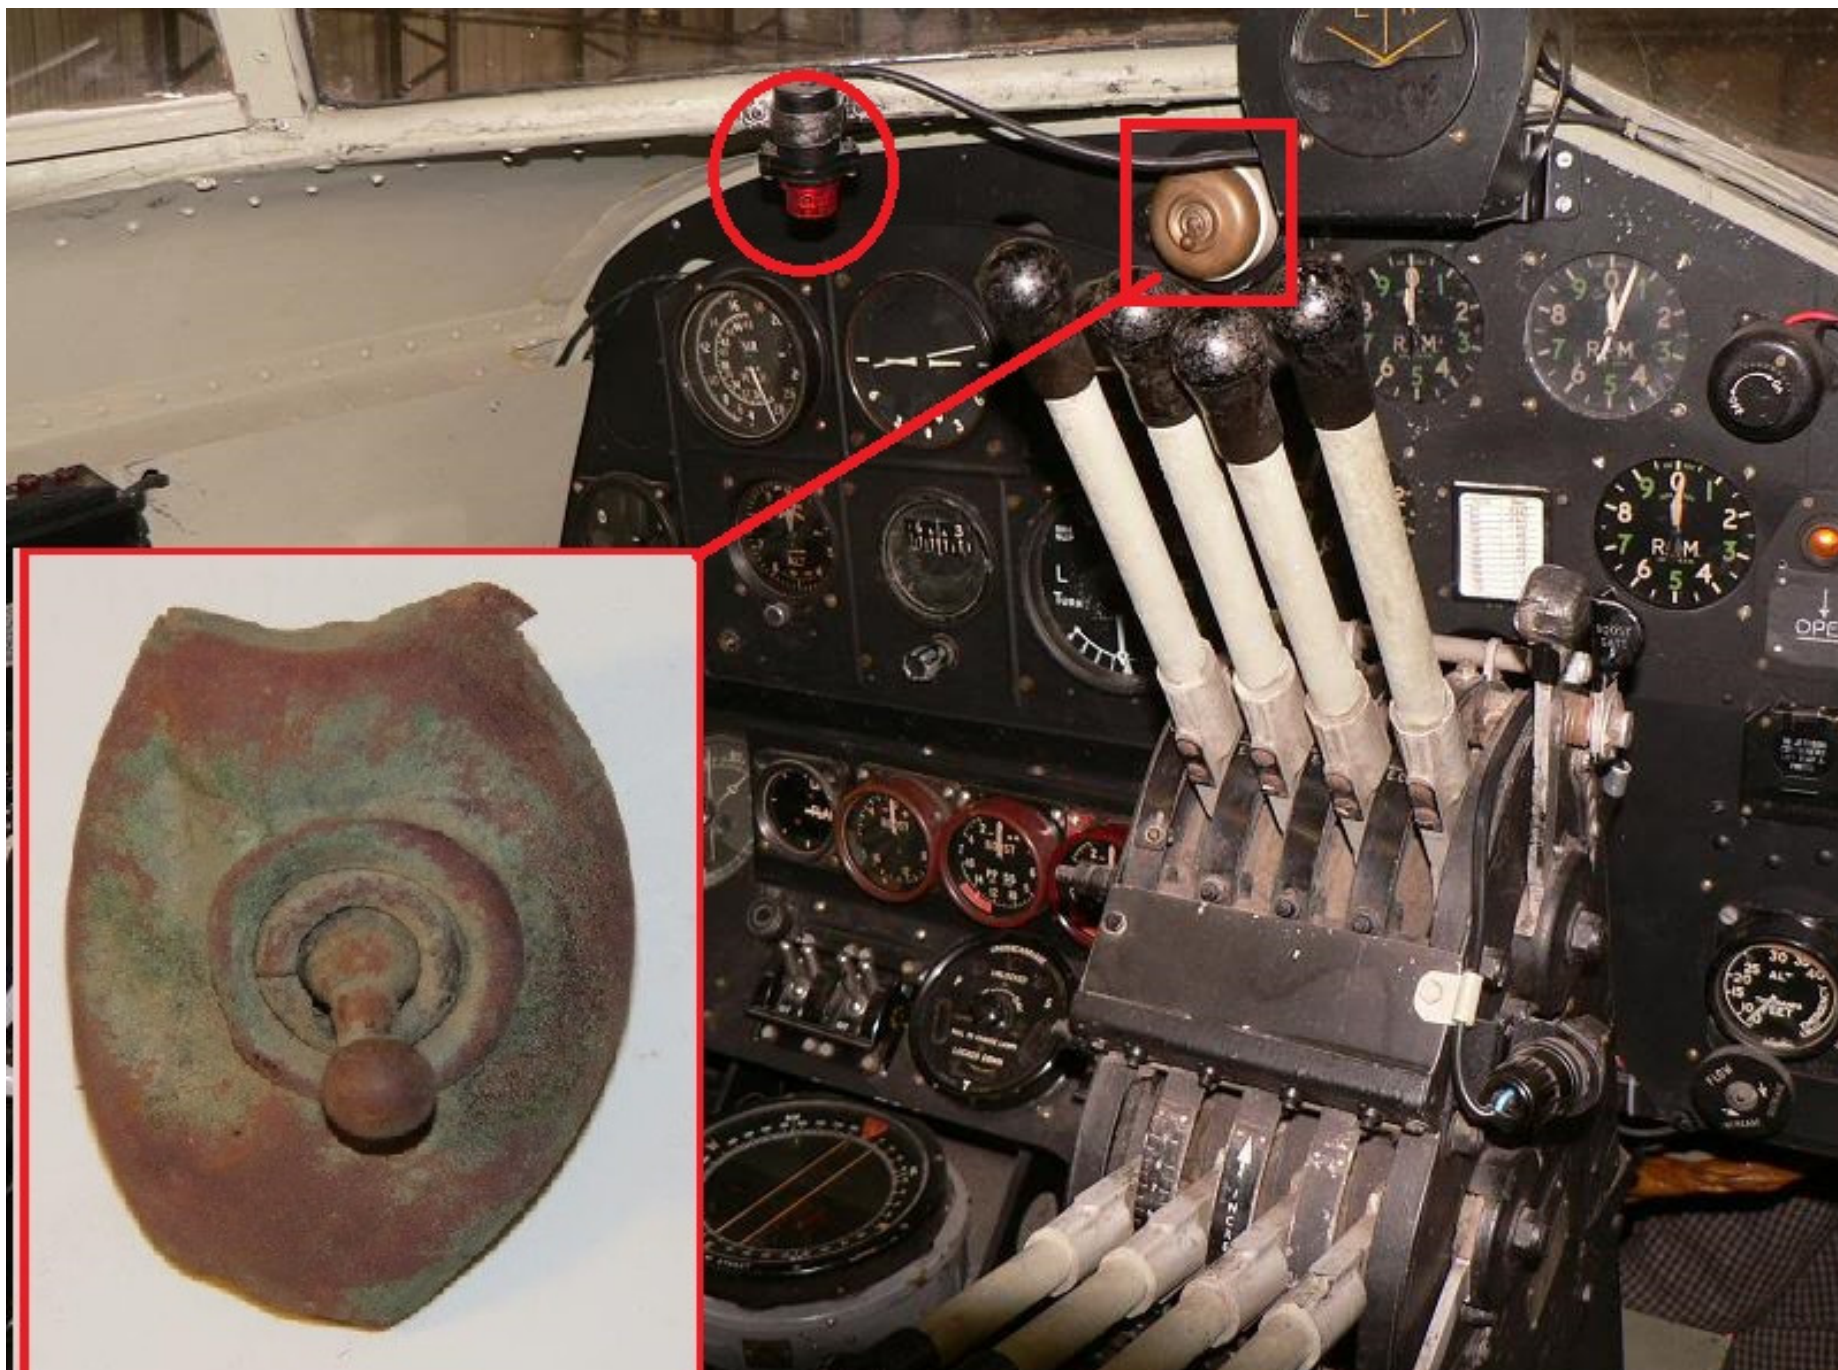
Definitive proof that the debris is from Halifax BB378 – here is a cockpit switch. We also found red plexiglas.

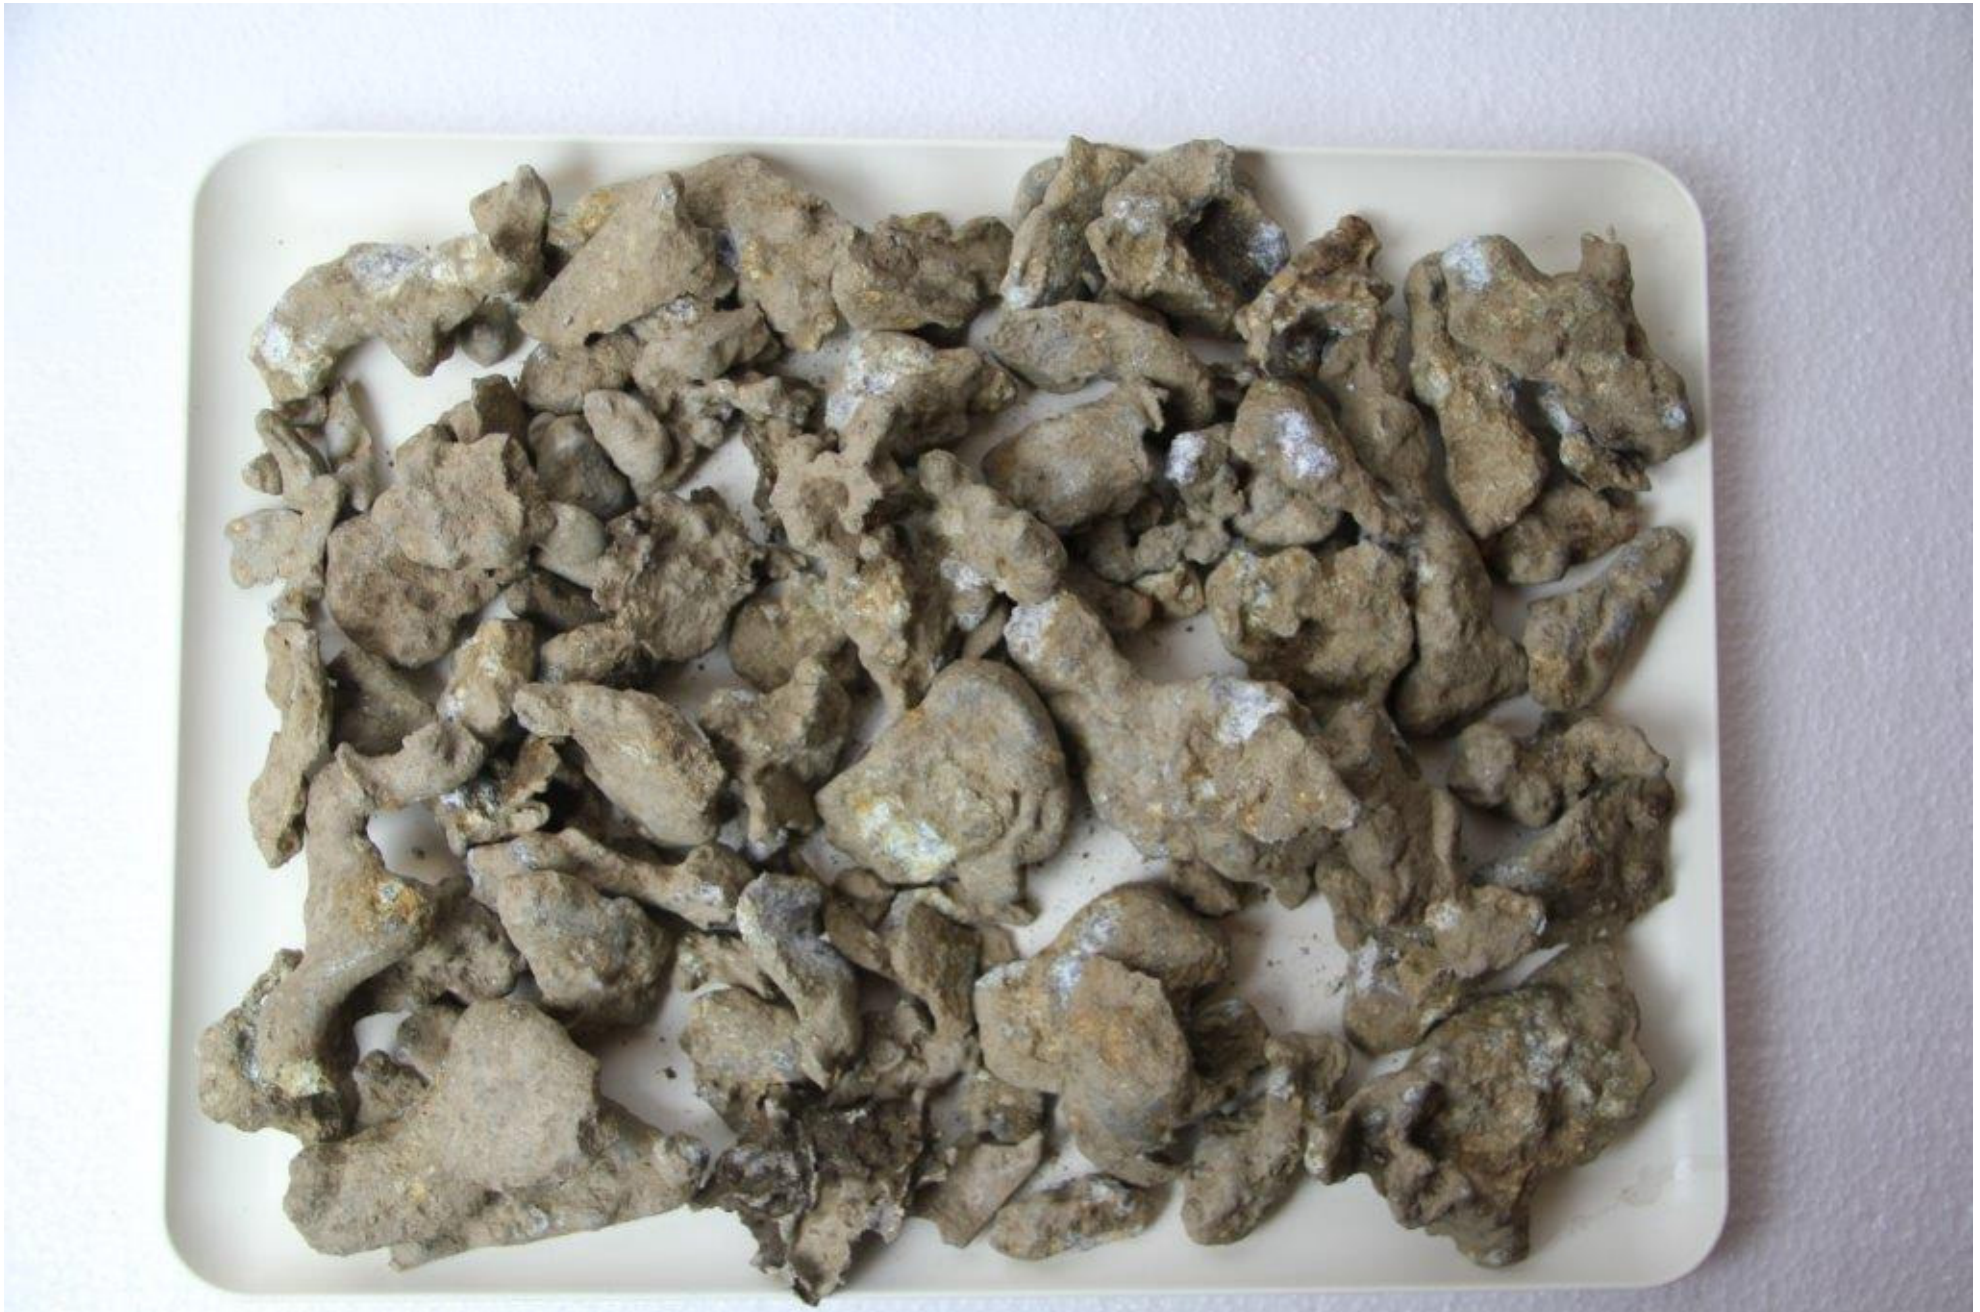
Debris field 1: Molten aluminium from the aircraft fire (100 pieces, 3 kg).

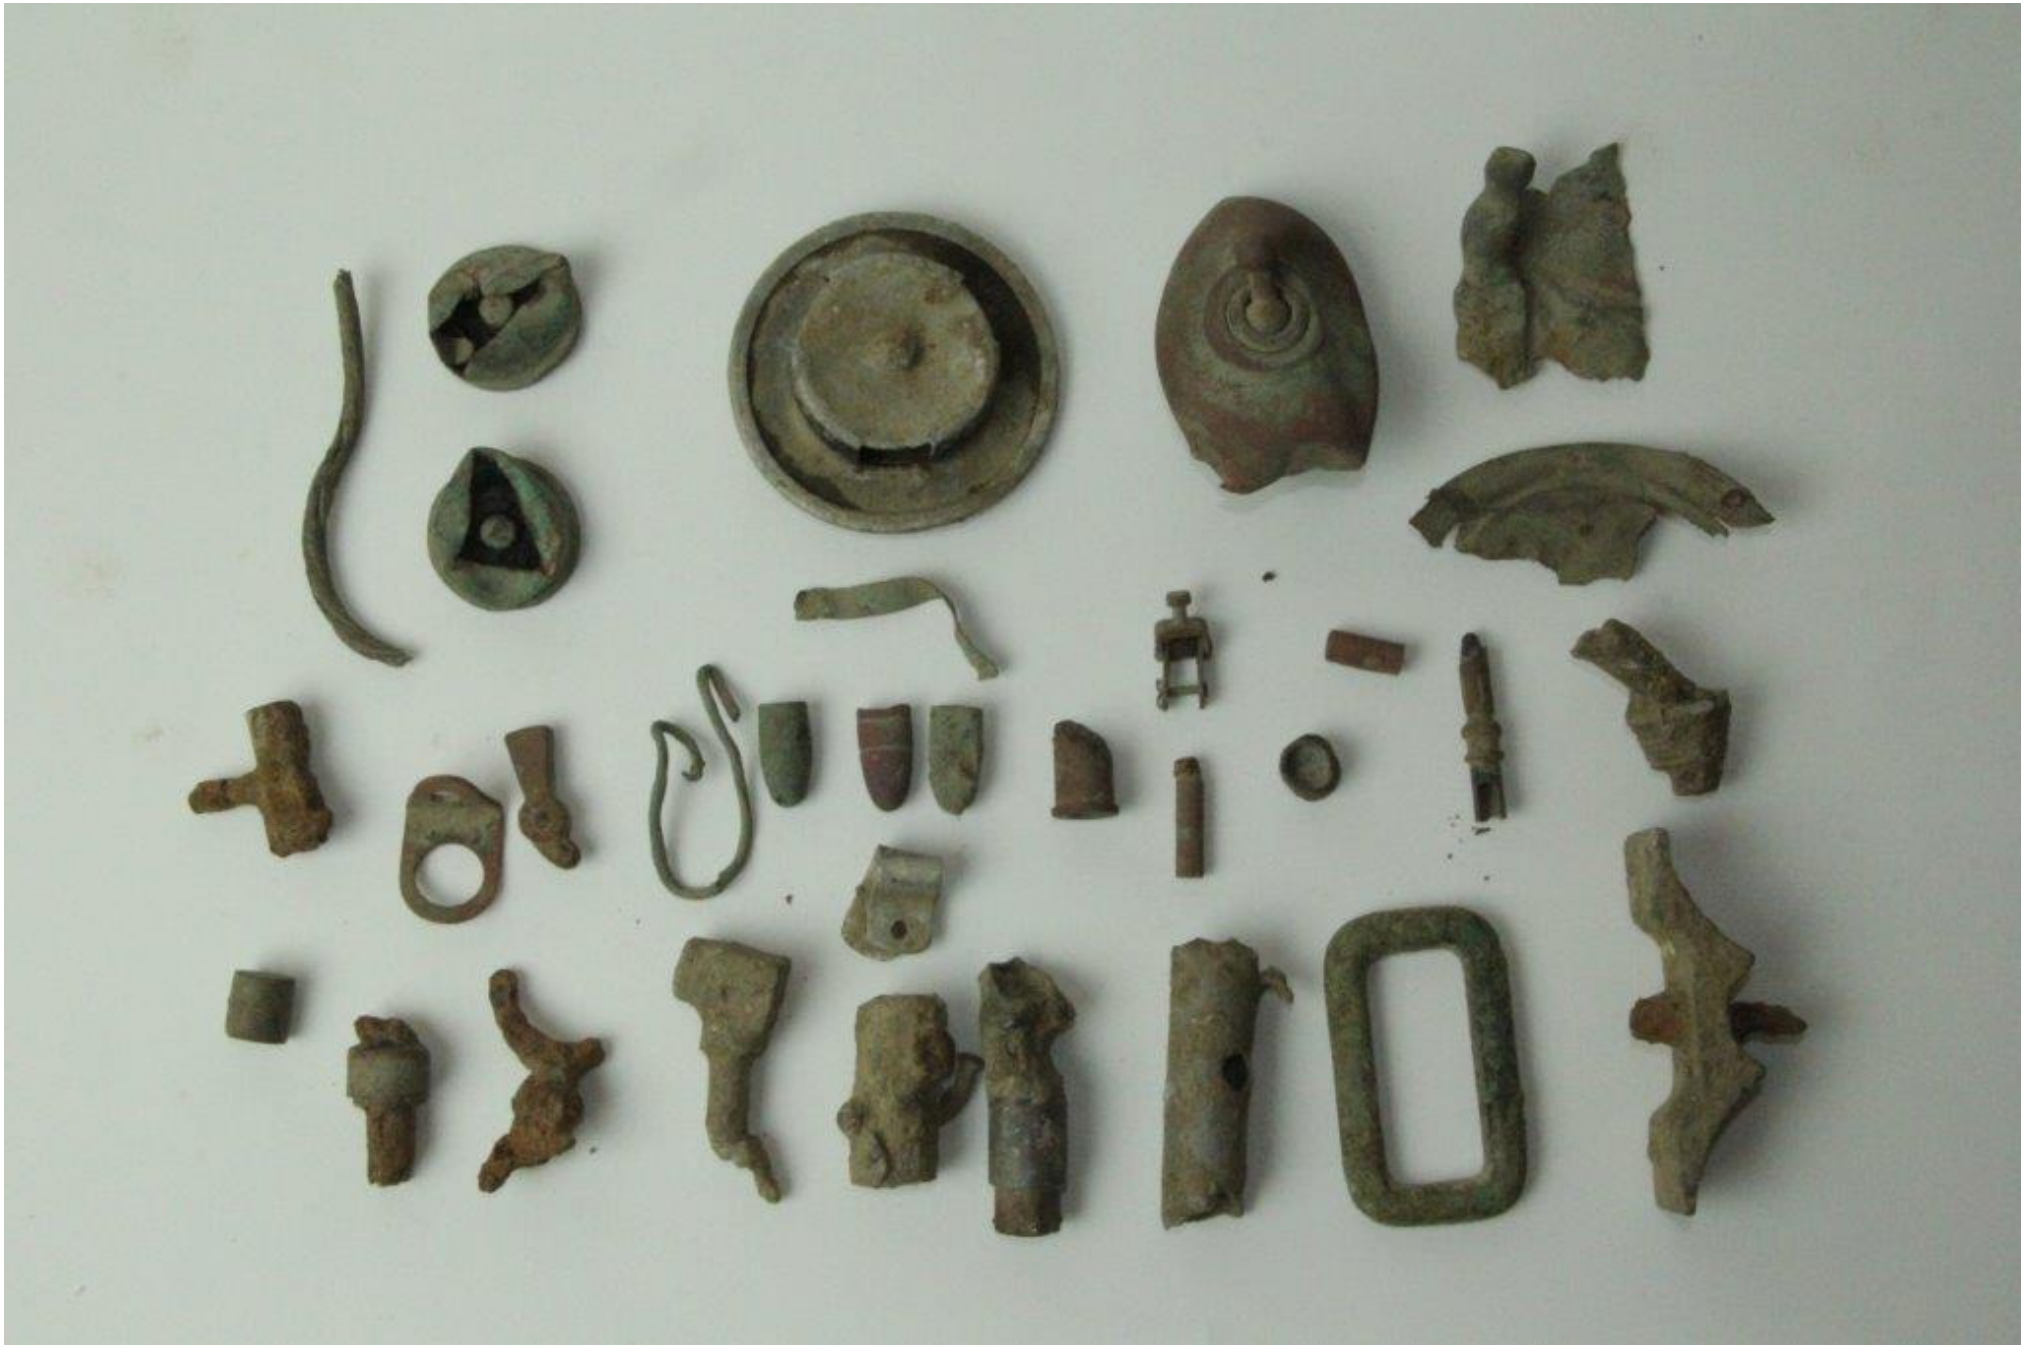
Debris field 1: Various items, including the cockpit switch, two signal pistol cartridges and a .303 calibre cartridge.

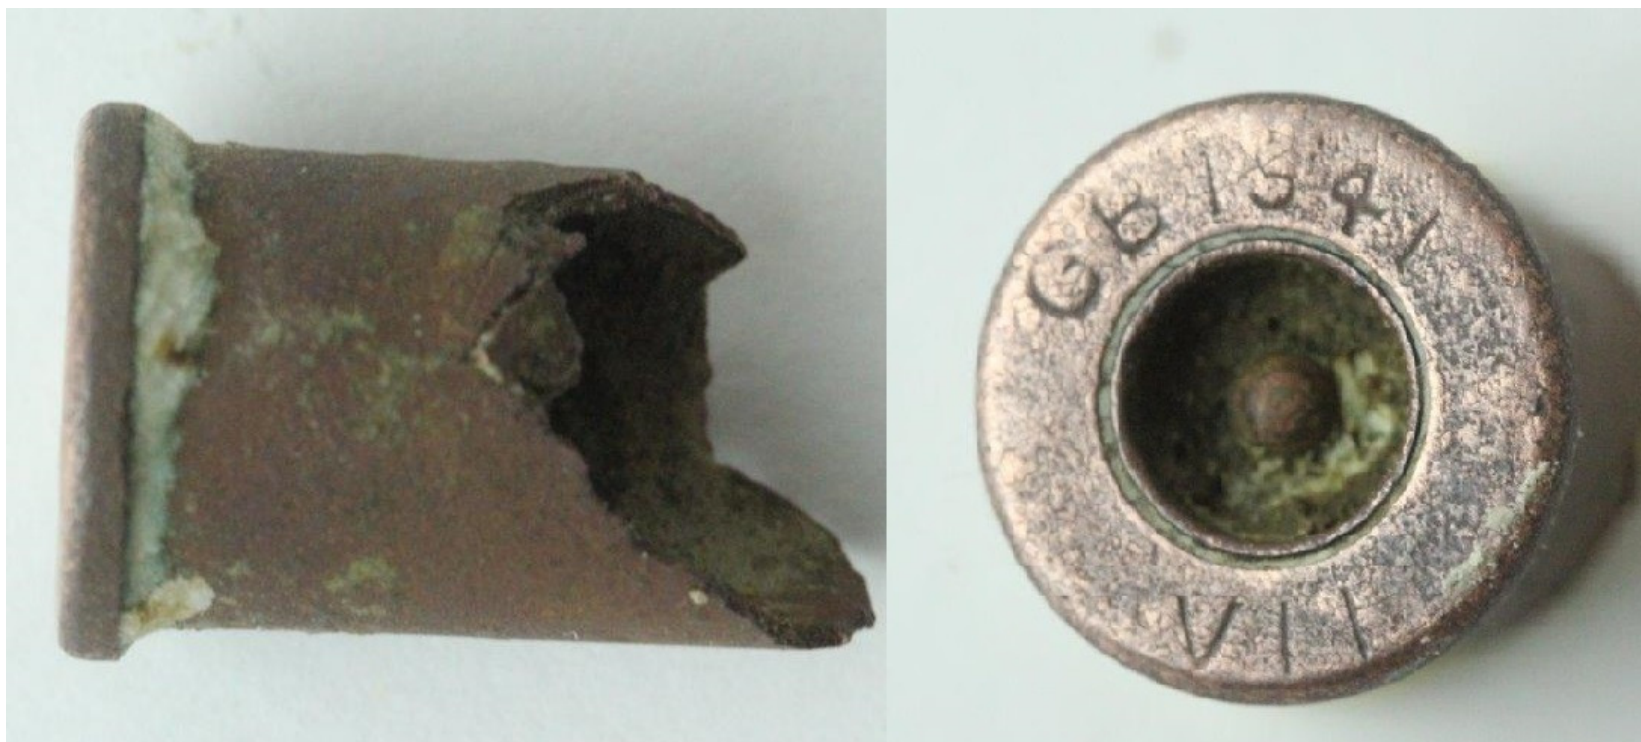
Debris field 1: Cartridge fragment. Identified as a .303 calibre Mk. 7-projectile for a .303 calibre Browning machinegun, of which BB378 was equipped with four. Manufactured by Greenwood and Batley, Leeds, UK in 1941.

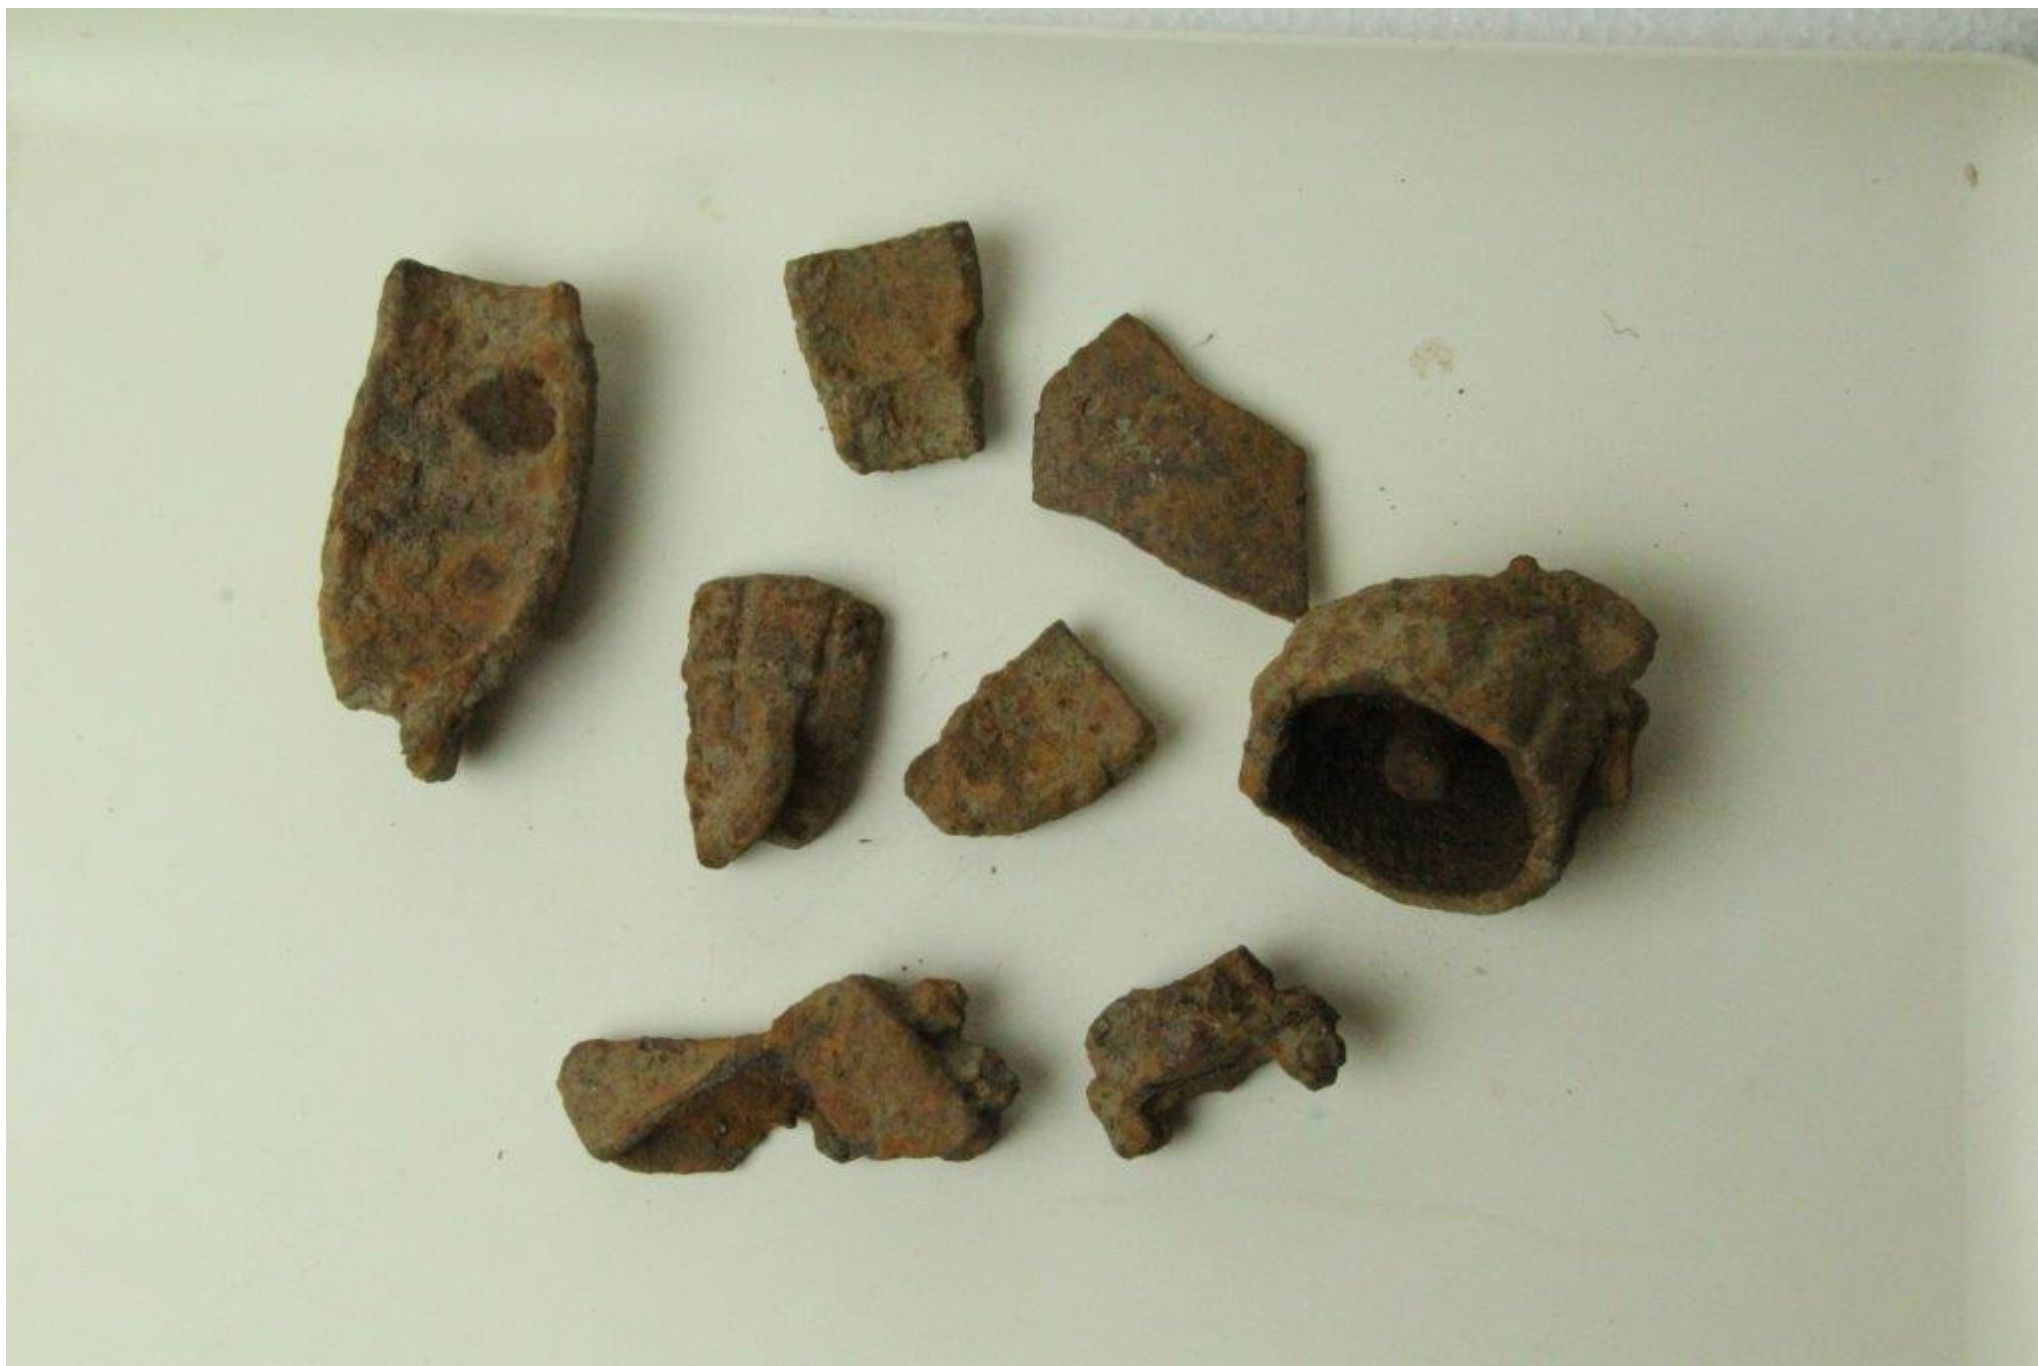
Debris field 1: Various iron items, including fragments of Mill's hand grenades from BB378.

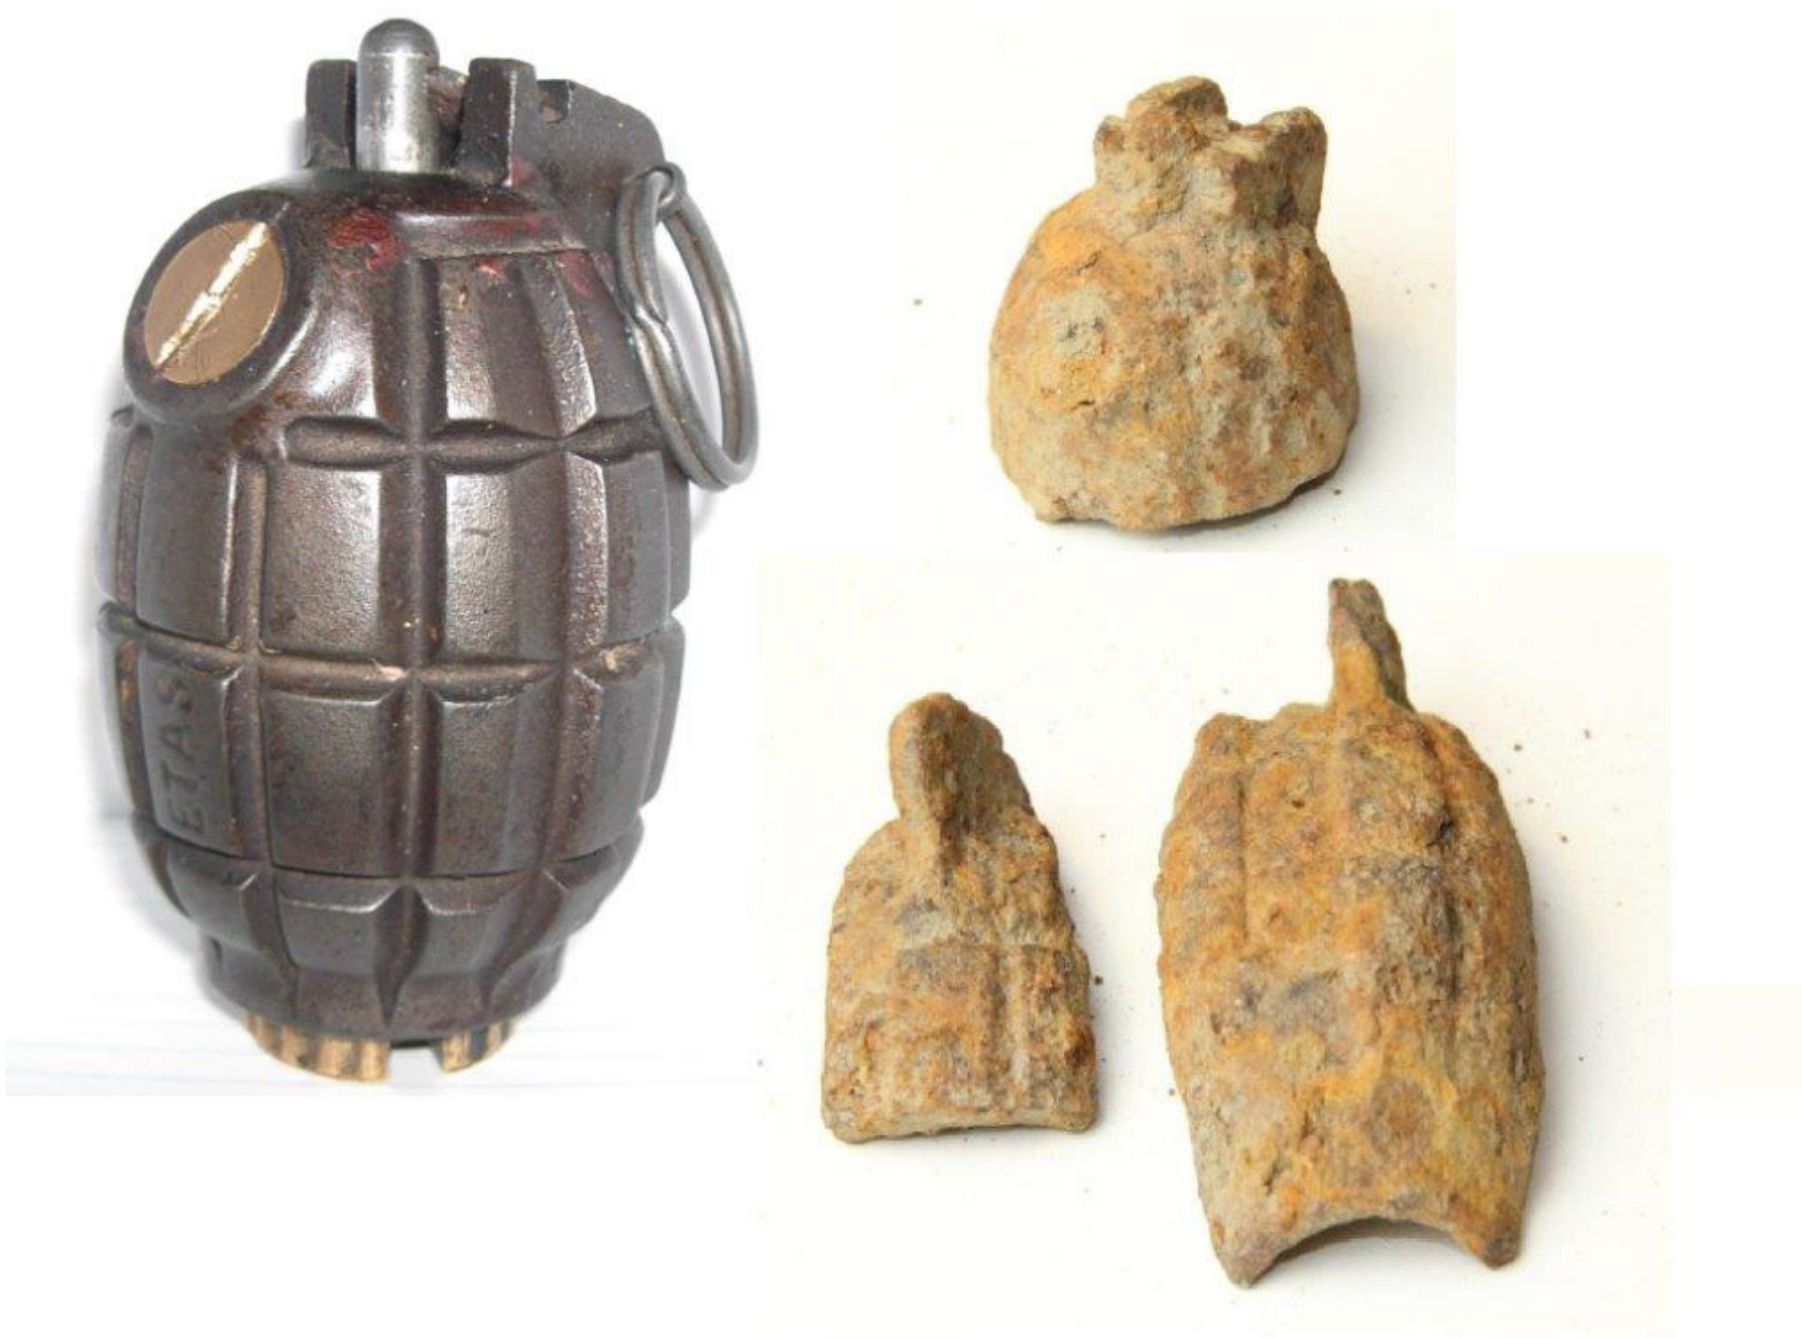
Debris field 1: Fragments (right) from the Mill's hand grenades (left) that BB378 was to deliver to the Danish resistance.

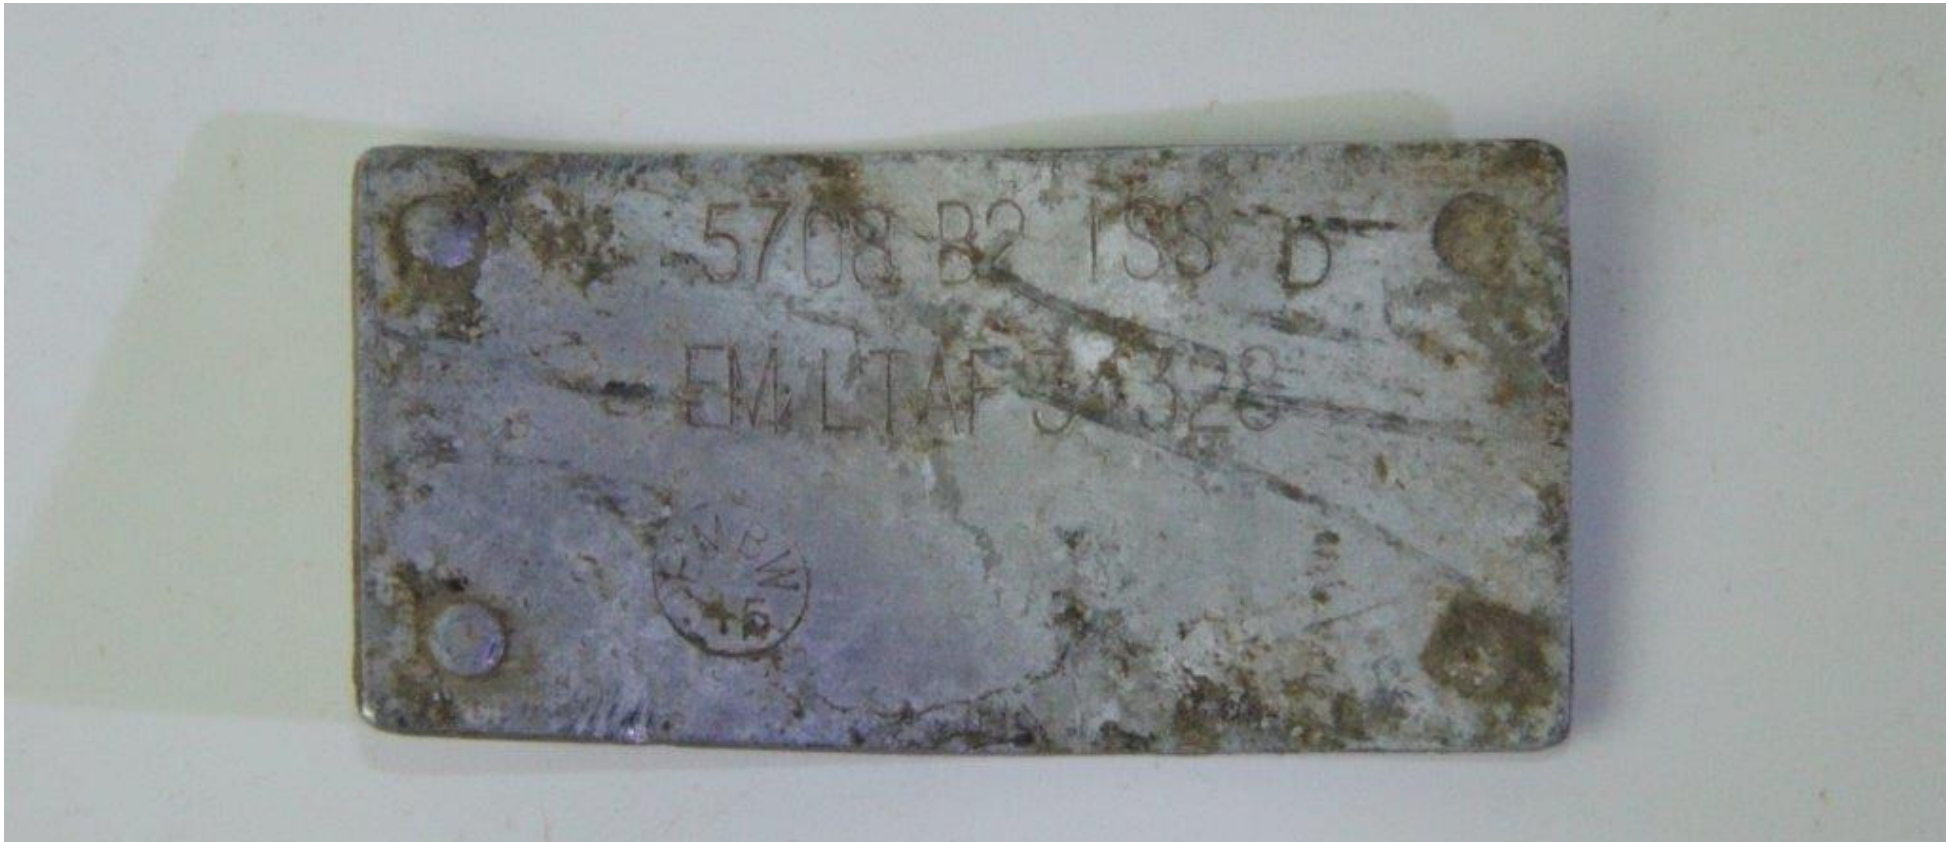
Debris field 1: Aluminium wreckage with part numbers and inspection stamps. Other examples follow on the next pages.

This item is engraved 5708 B2 ISS D EM LF AF 34328 EMBW 45. According to Jan Christensen, other items of wreckage from Halifax crash sites in the UK contain similar part numbers to “5708 B2 ISS”, and many have the stamp “EMBW”. See for example:

The similarity of parts numbers and inspection stamps indicates that our debris is from a Halifax and hence from BB378.

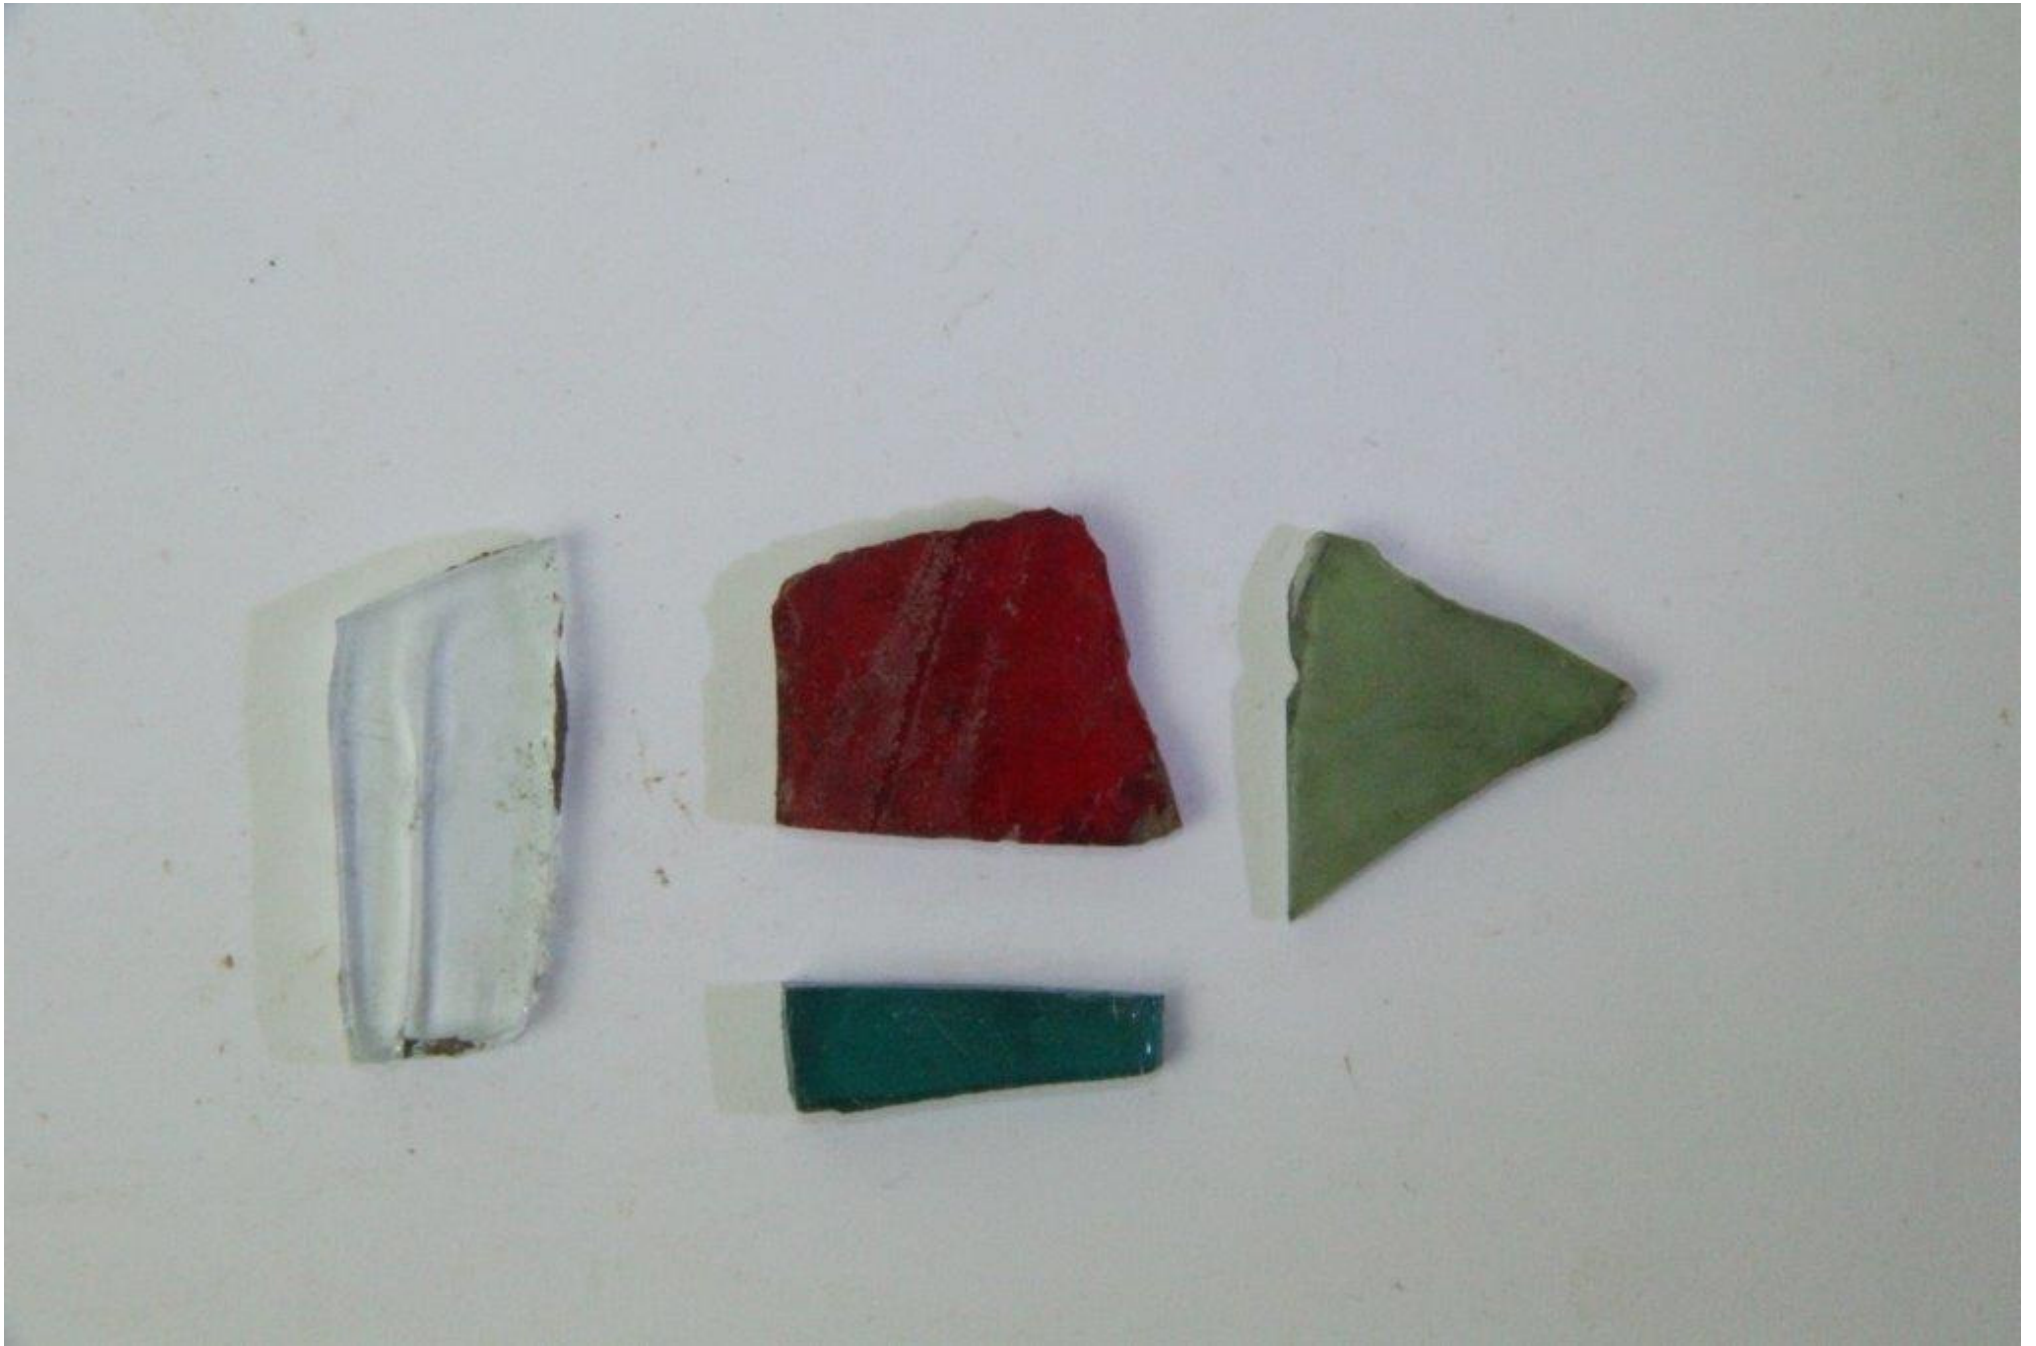
Debris field 1: Plexiglas. Red could be from the cockpit lamp. Red and green could be from the wing lights.
