**On the trail of Halifax bomber BB378 of 138 Squadron from RAF Tempsford  
Crash-landed in Denmark on 11.12.1943**

## **Metal detector survey**

**David Barry, Kalundborg Archaeology Society, 24.02.2015**  
**David@Barry.DK**

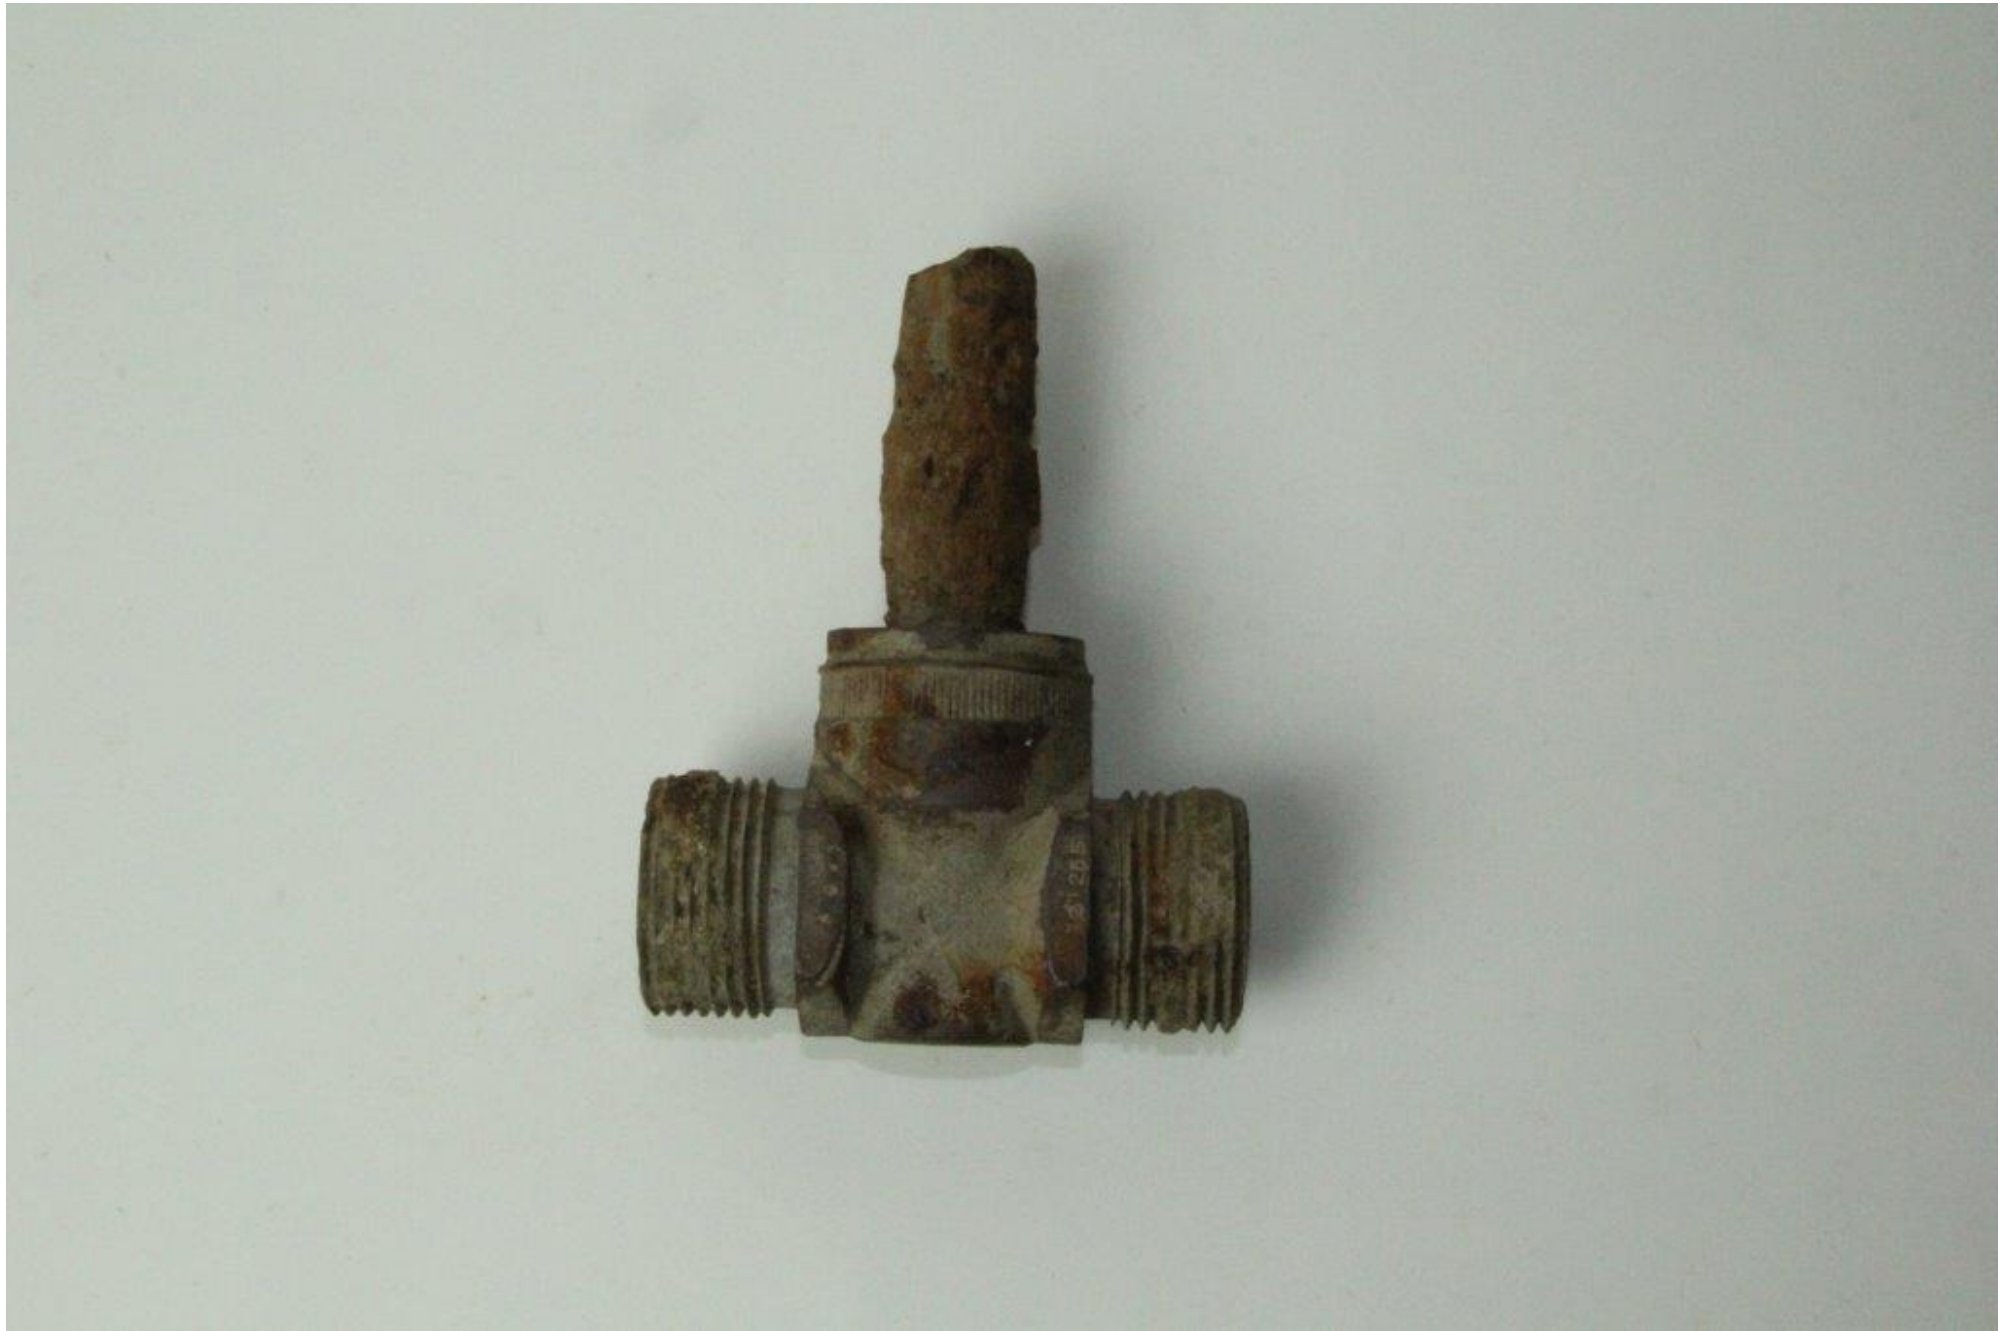
Debris field 1: Iron and brass engine fitting, perhaps a fuel connector.

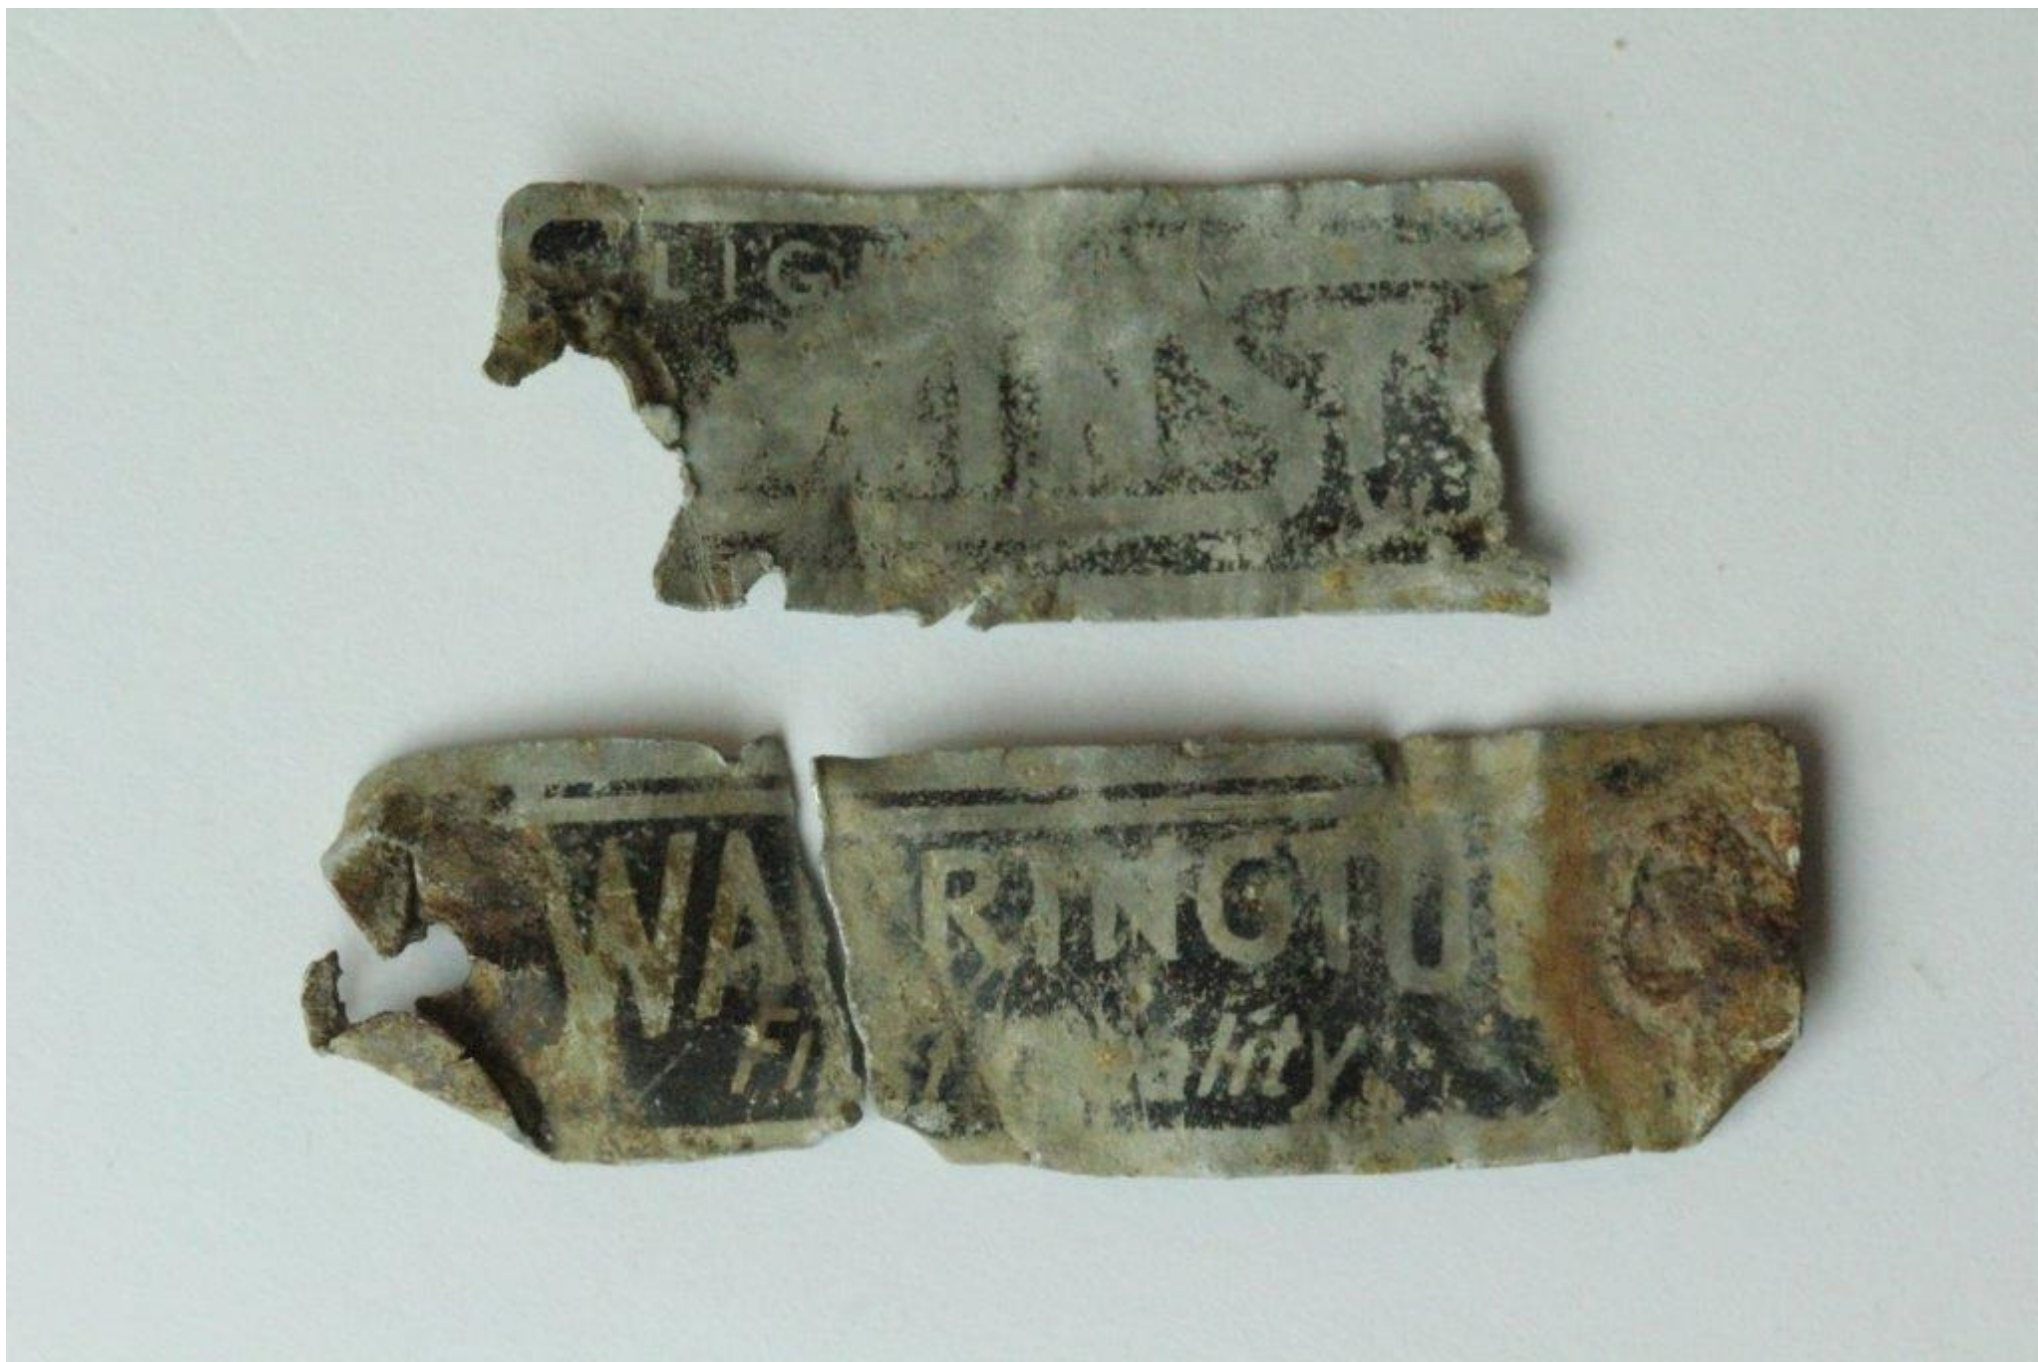
Aluminium name plates, one with the text "Warrington First Quality". Unclear if they are from BB378.

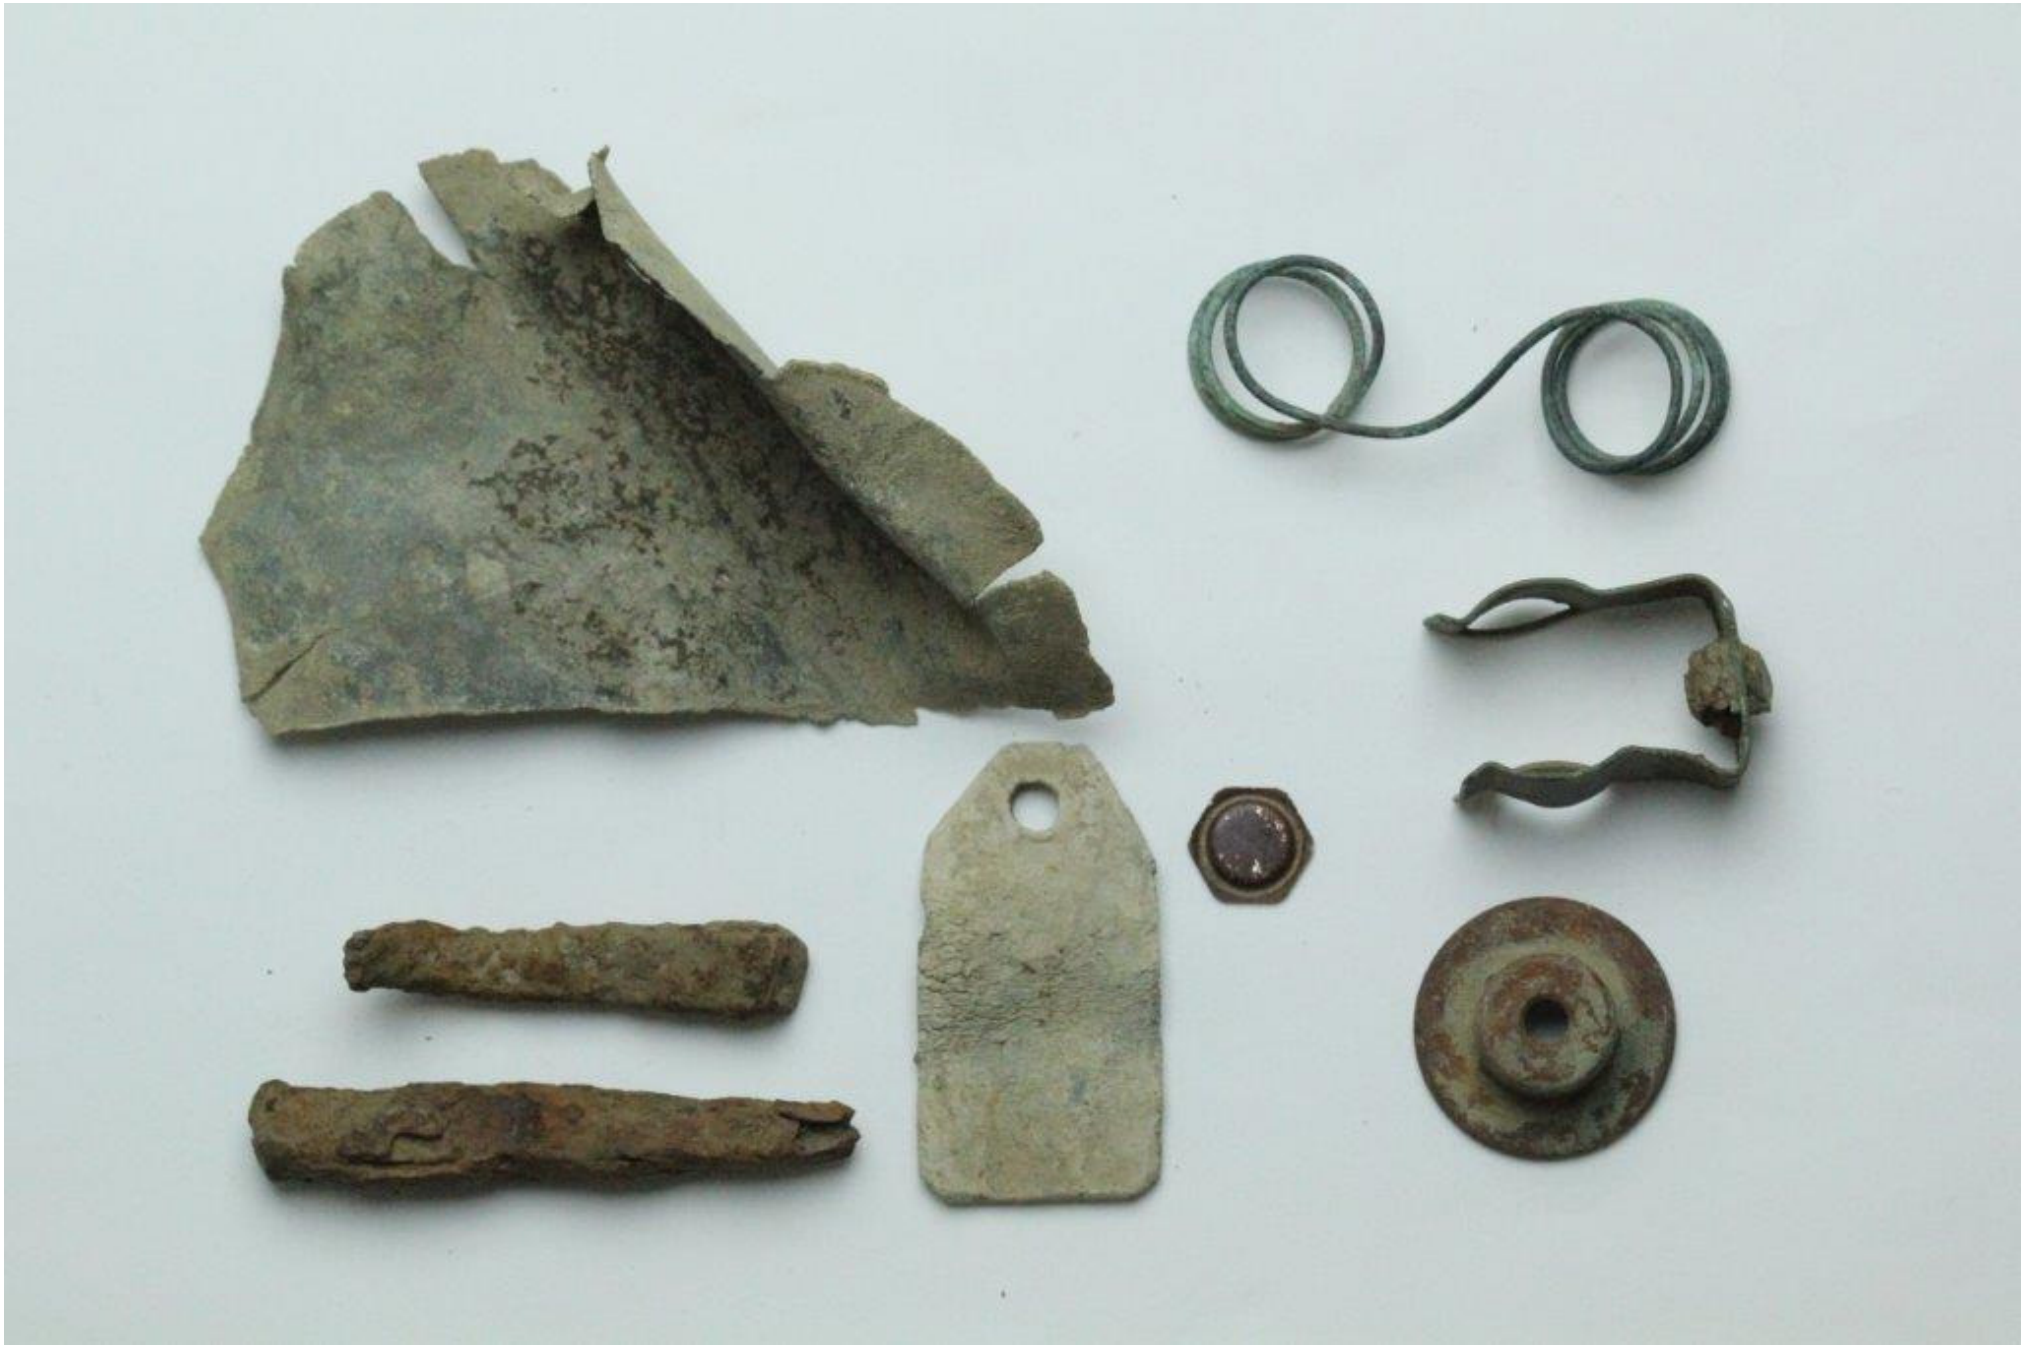
Items found on the hill slope north of Debris field 1. Some of the items could be from BB378's electrical system.

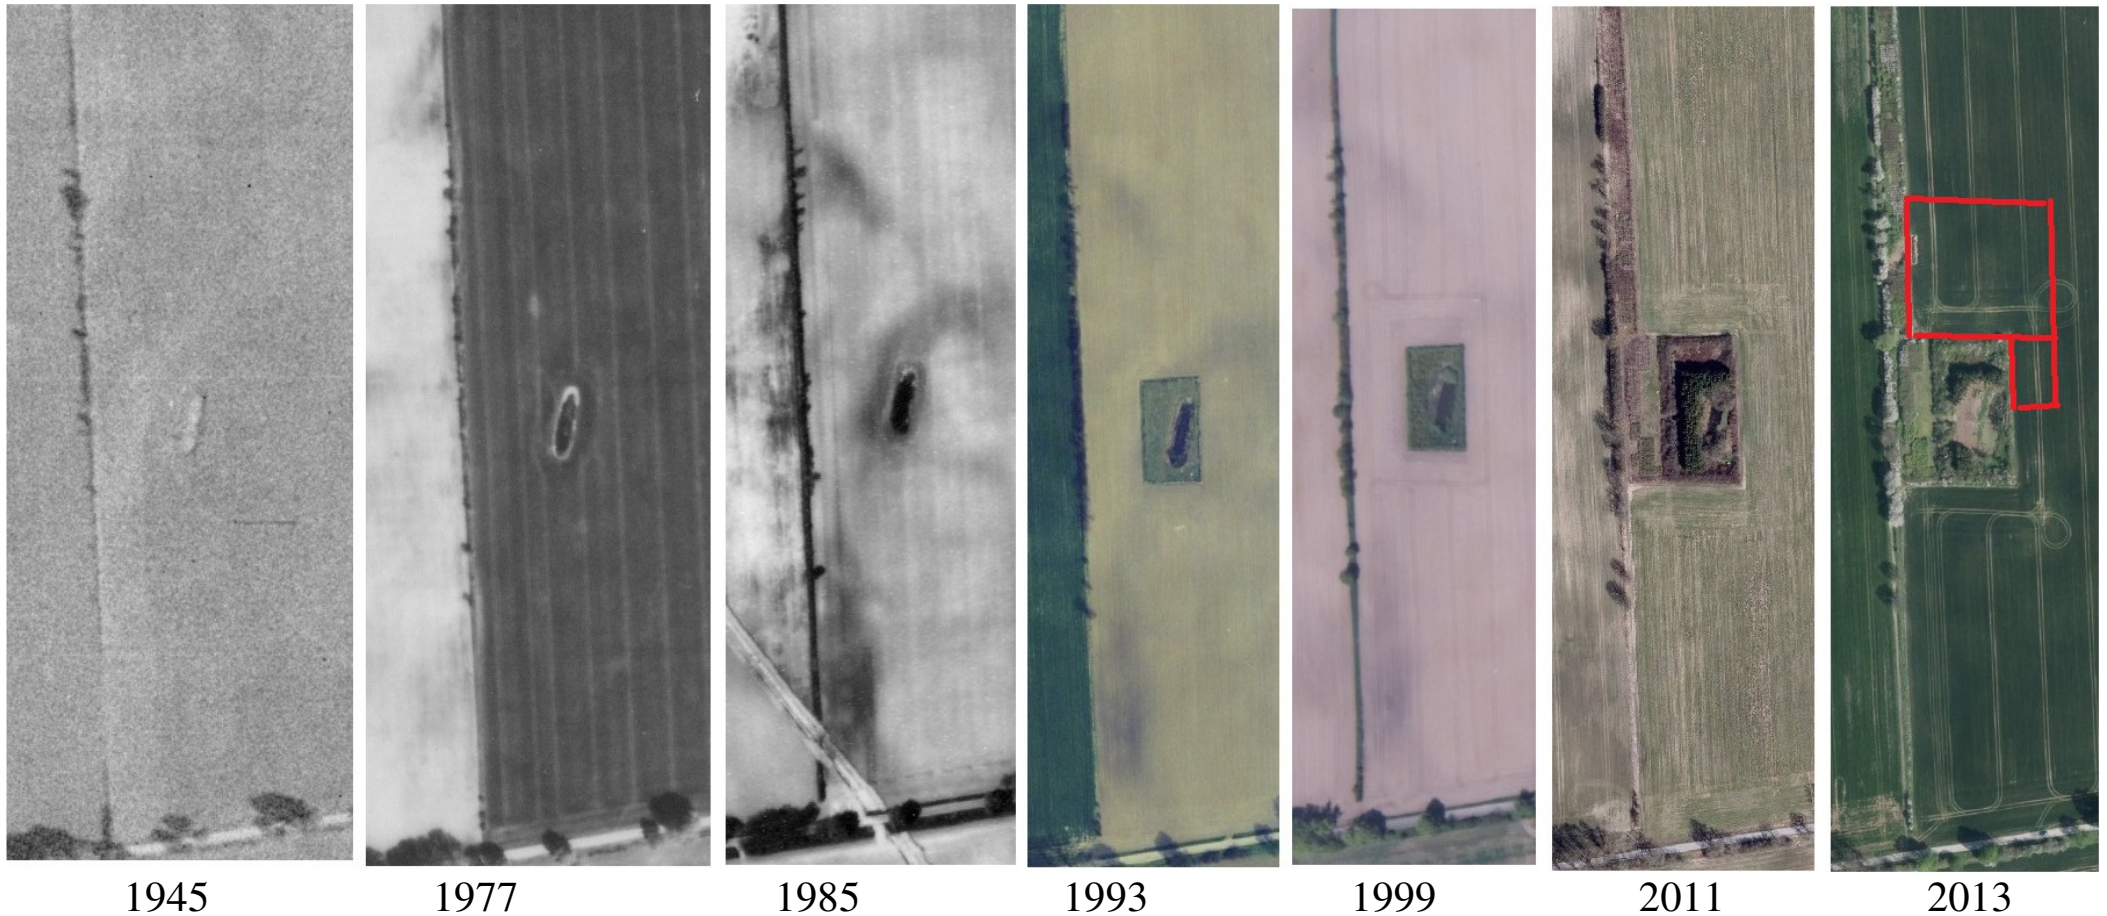
Crash-landing site. The two debris fields are indicated for 2013. The wooded area next to debris fields 1 and 2 did not exist in 1945 and was planted after 1999. The whole crash site was ploughed for about 50 years after the crash-landing and most of it for about 60 years. It is likely that there is more debris from BB378 in the wooded area, so further detecting is desirable. Three large pieces of aluminium have already been found there.
